DEPARTMENT OF TRANSPORTATION

Contract #: 04-0120F4Cty: SF/ALA Rte: 80 PM: 13.2/13.9File #: 69.28**WELDING INSPECTION REPORT****Resident Engineer:** Siegenthaler, Peter**Address:** 333 Burma Road**City:** Oakland, CA 94607**Report No:** WIR-020367**Date Inspected:** 01-Sep-2010**Project Name:** SAS Superstructure**OSM Arrival Time:** 700**Prime Contractor:** American Bridge/Fluor Enterprises, a JV**OSM Departure Time:** 1900**Contractor:** Zhenhua Port Machinery Company, Ltd (ZPMC), Changxing Island **Location:** Shanghai, China**CWI Name:** Liu Hua Jie**CWI Present:** Yes No**Inspected CWI report:** Yes No N/A**Rod Oven in Use:** Yes No N/A**Electrode to specification:** Yes No N/A**Weld Procedures Followed:** Yes No N/A**Qualified Welders:** Yes No N/A**Verified Joint Fit-up:** Yes No N/A**Approved Drawings:** Yes No N/A**Approved WPS:** Yes No N/A**Delayed / Cancelled:** Yes No N/A**Bridge No:** 34-0006**Component:** OBG Segment Assembly**Summary of Items Observed:**

OBG Segment 10BW-10CW

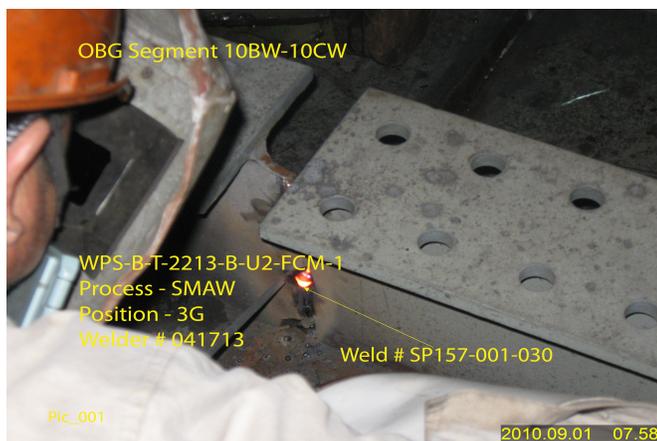
Shielded Metal Arc Welding (SMAW) in the 3G position of Bottom Panel 'T' rib splice weld # SP157-001-030. The welder is identified as 041713. ZPMC Quality Control (QC) is identified as Wang Zhu. The welding variables recorded by QC appeared to comply with WPS-B-T-2213-B-U2-FCM-1. See attached photograph Pic_001
